7th International Building Physics Conference

IBPC2018

Interior insulation retrofit of a brick wall using super insulation materials: design of a field testing in an industrial brick building

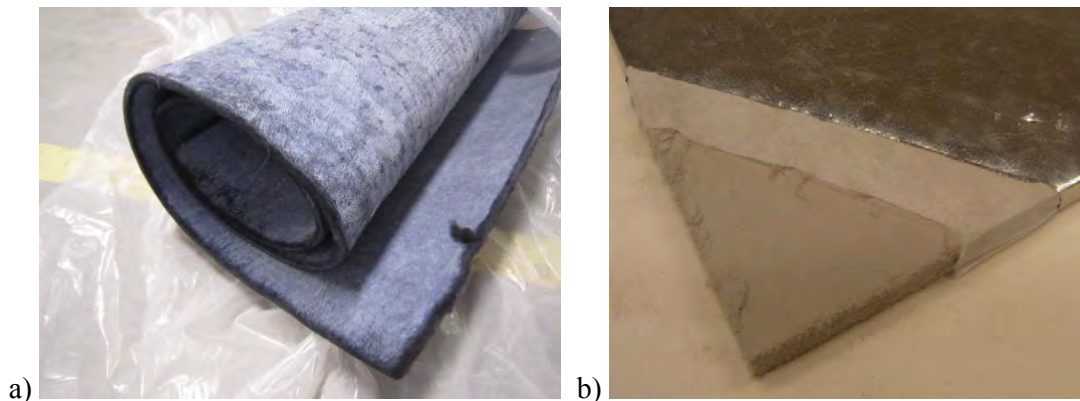
Figure 1. Super insulation materials; a) aerogel blanket (AB), b) vacuum insulation panel (VIP).

When the thickness of the insulation layer is limited, SIM may be used. Two examples of SIM are AB and VIP, see Figure 1. VIP are rigid panels which cannot be cut on site and are sensitive to puncturing. Therefore, attention has to be paid in the design of details and envelope components. AB are more similar to conventional fiber-based insulation materials. They can be cut at the construction site and adapted to the specific measurements. VIP were first tested in buildings in the early 1990s which were later followed by several case studies both in laboratory and in the field. AB have been installed in various building assemblies since the early 2000s (Adl-Zarrabi & Johansson, 2018).

Among the important material properties for building materials are thermal conductivity, heat capacity and vapor diffusion resistance. The hygrothermal properties for AB and VIP differ substantially. The thermal conductivity of AB is 0.015-0.020 W/(m·K) and 0.002-0.008 W/(m·K) for VIP (Heinemann, 2018). The vapor diffusion resistance of AB is around $\mu=5$ which is a factor five higher than mineral wool. The blankets are coated with a water repellent substance which reduce the liquid water transfer. The VIP on the other hand, are

wrapped in an air and moisture tight metallized multi-layered polymer laminate which gives a vapor and liquid water transfer only at the edges between the VIP (Johansson et al., 2014b).

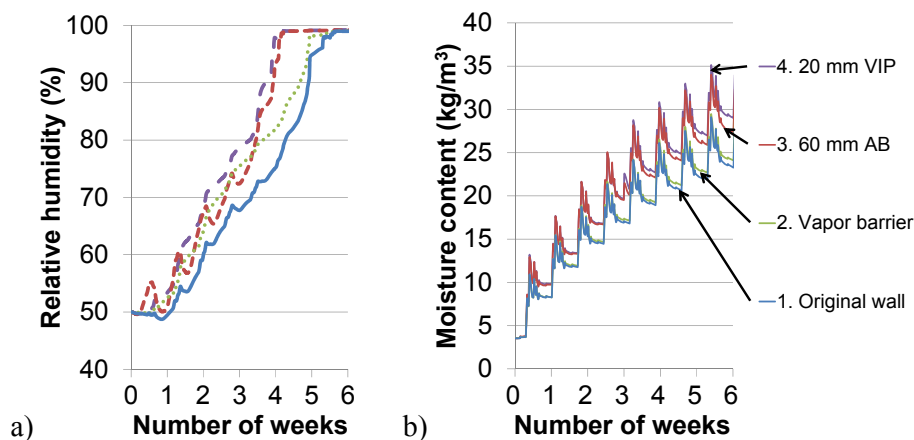
Figure 2. a) Numerically simulated RH 60 mm from the interior of the brick. b) Numerically simulated moisture content in a 250 mm thick wall (adapted from (Johansson et al., 2014a)).

The initial conditions of the materials were 20°C and 50% RH and the interior climate was 20°C and 40% RH. The exterior climate was based on the HAMSTAD benchmark with an exterior surface heat transfer coefficient of 25 W/(m²·K) and a wind dependent vapor surface transfer coefficient. The walls were well protected with a rain water absorption factor of 0.1, i.e. a small amount of rain was available for capillary absorption assuming that the remaining water runs down the façade or splashes off at impact. The results from the one-dimensional numerical simulations of the four cases are shown in Figure 2.

Adding a vapor barrier to the interior of the brick wall does not change the total moisture content in the wall compared to the case without the vapor barrier. However, at the location 60 mm from the interior surface of the brick, the RH is higher than without the vapor barrier. This is caused by the restricted drying from the interior surface of the wall. In the two walls with a layer of interior insulation, both the RH and the moisture content increases compared to the case without interior insulation. The wall with the vapor open insulation has a slightly lower RH and moisture content than the wall with VIP. The main part of the vapor and water flow in the wall is caused by the rain on the exterior surface. Thus, the indoor moisture load is of minor importance for the conditions studied here.

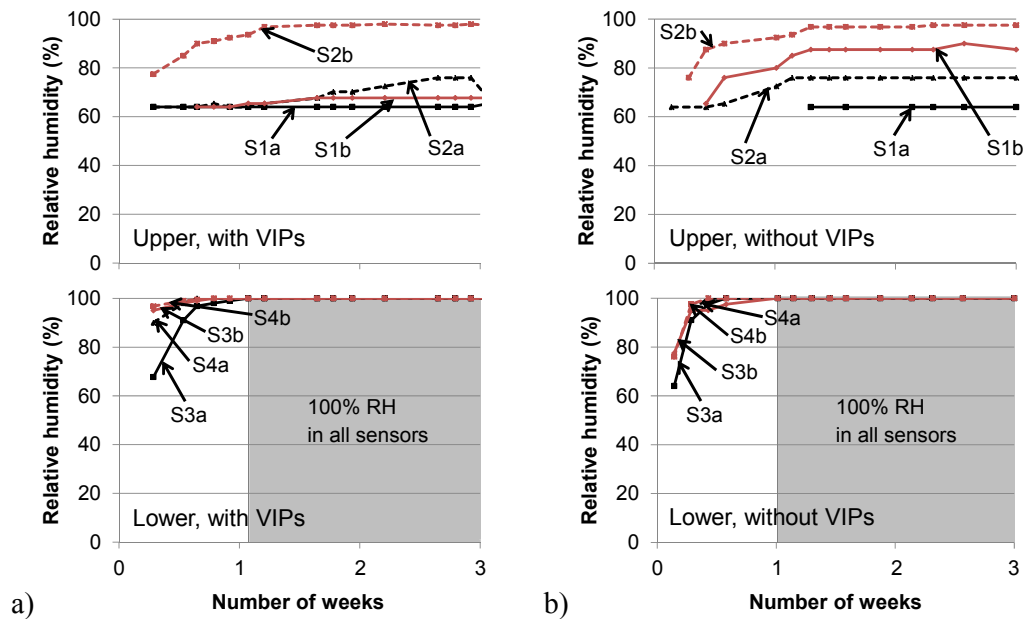
Figure 3. Measured moisture content: a) with VIP in the upper and lower parts of the wall. b) without VIP in the upper and lower parts of the wall. The sensors were located in the mortar in the middle of the wall (S1b-S4b) and in the mortar on the interior surface of the brick (S1a-S4a) (adapted from (Johansson et al., 2014a)).

Based on the results above, a brick wall was built in the laboratory of NTNU and SINTEF Building and Infrastructure in Trondheim, Norway. The wall was tested in a large-scale building envelope climate simulator where it was exposed to a temperature gradient and cycling climate with driving rain. The wall was first tested with 20 mm VIP on the interior and then without any layer on the interior side. The wall was divided in two parts (upper and lower) by a horizontal ledge made by a rubber strip to stop liquid water from being transported along the wall. Even though the temperature in the wall was lower in the case with interior VIP, the RH in the upper part of the wall increased more in the wall without VIP. For the lower part of the wall, the RH increased slower on the interior surface of the brick during the first few days, but was then equal to in the middle of the wall. The time before all sensors reached 100% was 180 h for the wall with interior VIP and 170 h for the wall without VIP.

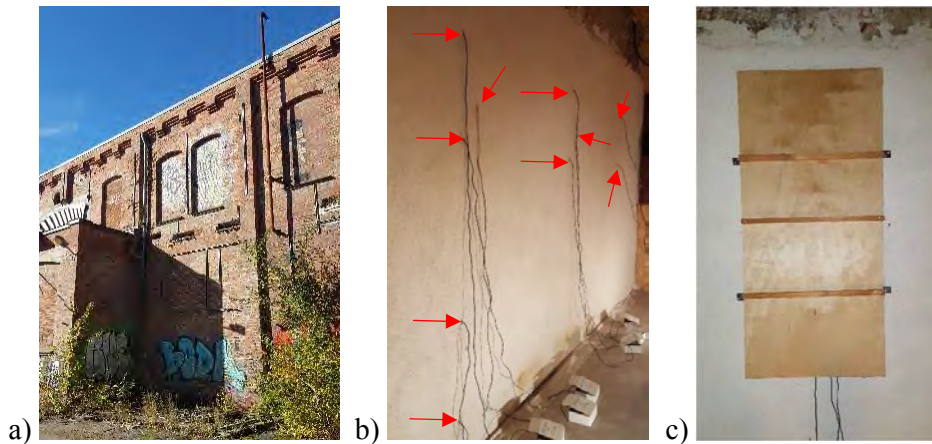
Figure 4. a) Industrial building from 1896 in south of Gothenburg, b) Sensors (marked with arrows) in the brick in the plastered brick wall, c) The test room with installed VIP and AB (removable for inspection of the wall).

deserted, the building was vandalized and degraded rapidly due to the cold and humid climate. The remaining heritage values and character defining elements of the building have been evaluated and one of the features that are considered important is the brick façade. Therefore, interior insulation is thought to be an interesting solution to reach sufficient energy performance. A small room was constructed inside the building with insulated (170 mm mineral wool) floor, walls and roof and the exposed brick wall, see Figure 4.

The brick wall is divided into three parts (500 x 1,200 mm) where AB and VIP is tested and compared to a non-insulated reference. The wall is equipped with 10 hygrothermal sensors that every hour register the temperature and relative humidity. The sensors are wireless Sahlén sensors (wood moisture sensors) which measure the weight percentage moisture in a piece of birch around the sensor. The measurement range corresponds to 60% to 100% RH. The size of the sensors is 40 mm x 13 mm (height x diameter), inserted in a 15 mm wide hole in the wall.
